1 **Request IR-1:**

3 **What is the P99 budget for the Maritime Link project, and what is the P99 scheduled**
4 **completion date?**

The challenge of ensuring the integrity of the submarine power cables: getting the power back to shore is the subject of this Report. Some 70% of insurance claims for offshore wind farms come from the submarine cables. Loss of power, for an extended period may lead to further damages to the turbine equipment/structure.

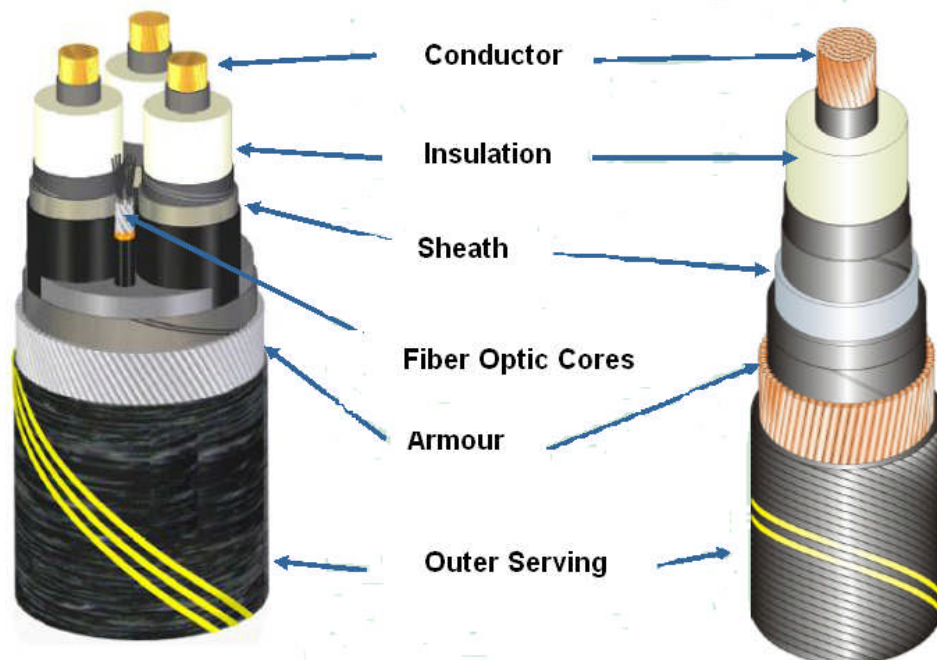
Figure 4.8: Typical 3 Phase AC Cable bundled with Fiber optic and Single Cable

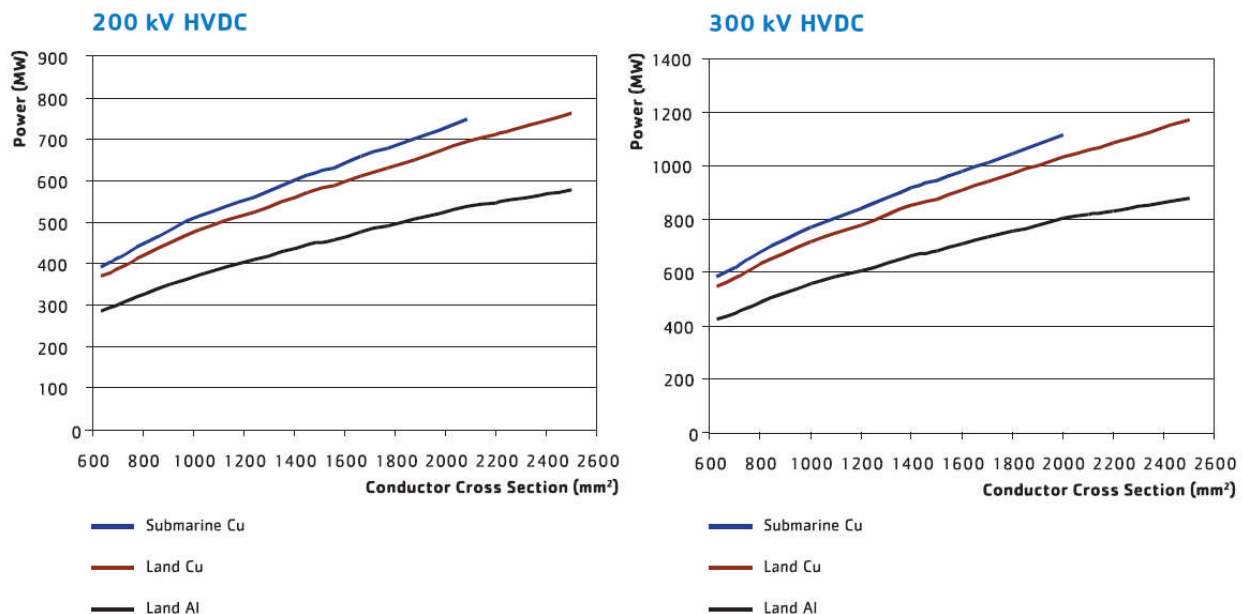
As an illustration of the differences between copper and aluminum and the variation with land vs. submarine the following figure shows for a DC cable the required cross-section area as a function of power required for offshore and for land for both copper and aluminum. Submarine copper cable is the smallest size required. Land cable requires a slightly larger cross section as the temperature is not dissipated with the water, and aluminum requires an even larger cross-section for the same power.

Figure 4.9: Nominal Power for 2 applications of HVDC and various Conductor Cross-sections
[Courtesy: Nexans' Brochure]

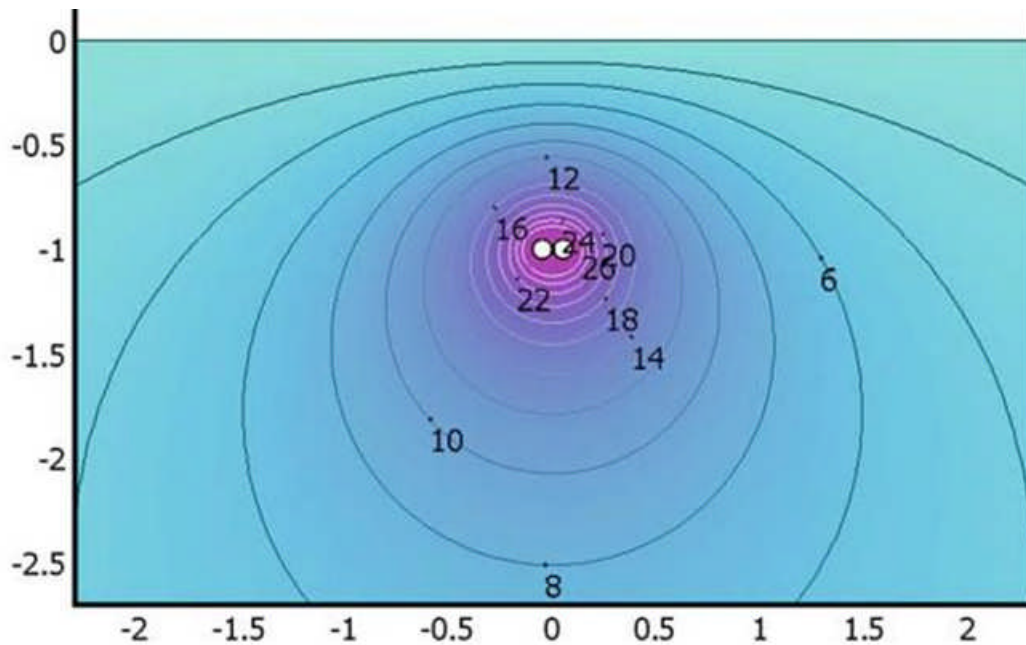
Figure 4.11: Temperature contours around a pair of submarine HVDC cables. x-axis is horizontal distance in meters, y-axis vertical depth below seafloor in meters (cable is at -1 m depth), and numbers in the diagram is the temperature rise above the seabed temperature in °C [Ref. 3.36]

As can be seen from Figure 4.11, a happy cable is likely to be some 20°+ above the ambient temperature. Temperature limits on XLPE cables is 90° C so based on a reasonable temperature in the water Figure 4.11 shows an acceptable situation. As such a cable comes on land, it may be that an ambient temperature in summer may be more than this, and thus either the size of cable may need to be increased (lowering the resistance and thus heat) or some way found to lower the temperature around the cable by other means.

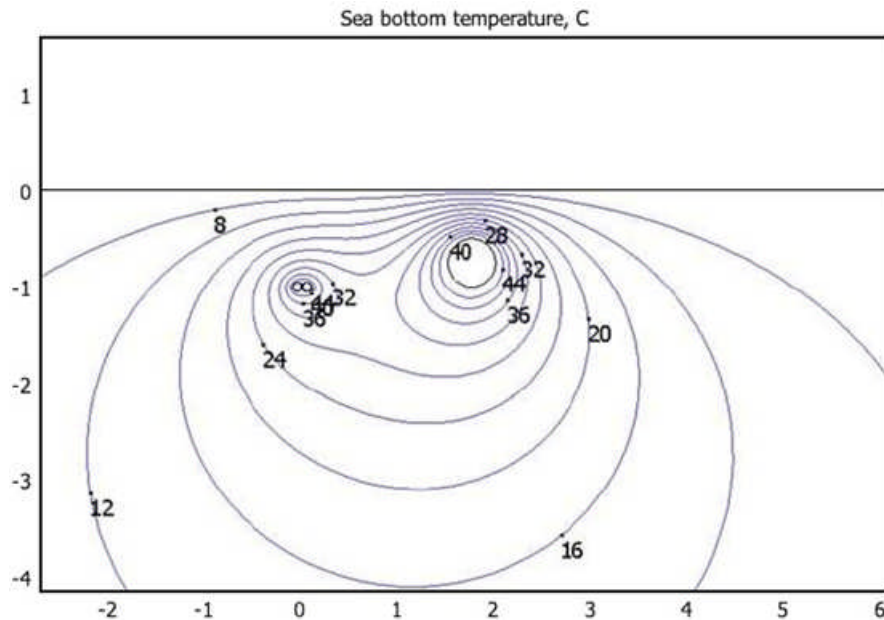
Figure 4.12: Temperature contours around a pair of submarine cables on the left and a pipeline on the right with a 50° C surface temperature.

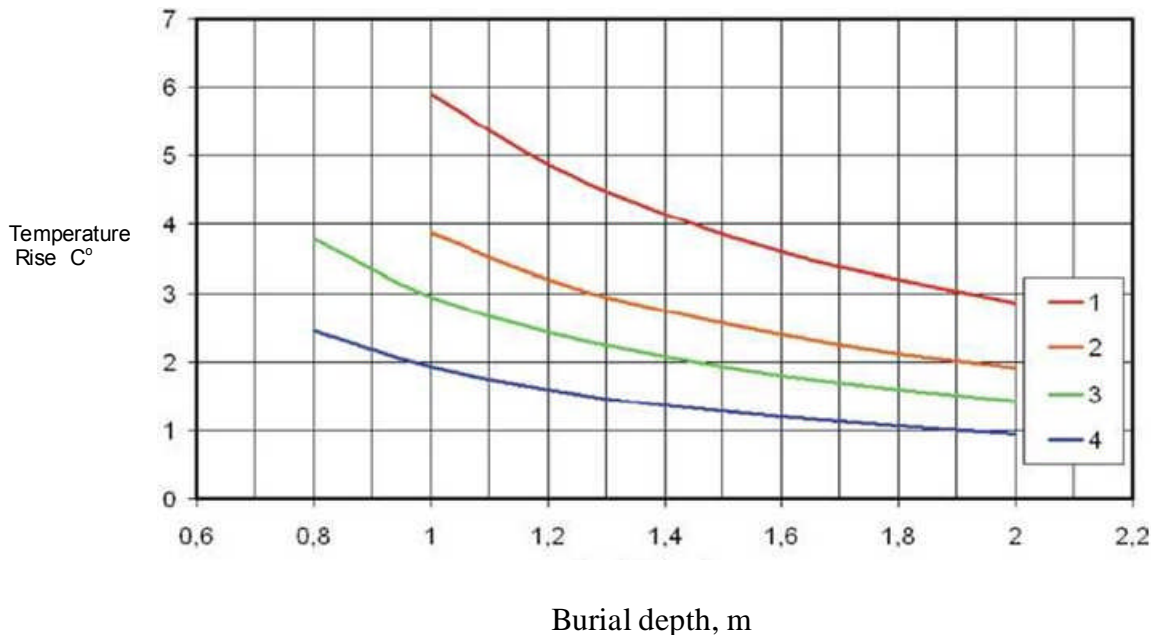
Figure 4.13: Temperature rise at -0.2m and -0.3m below the sea floor.

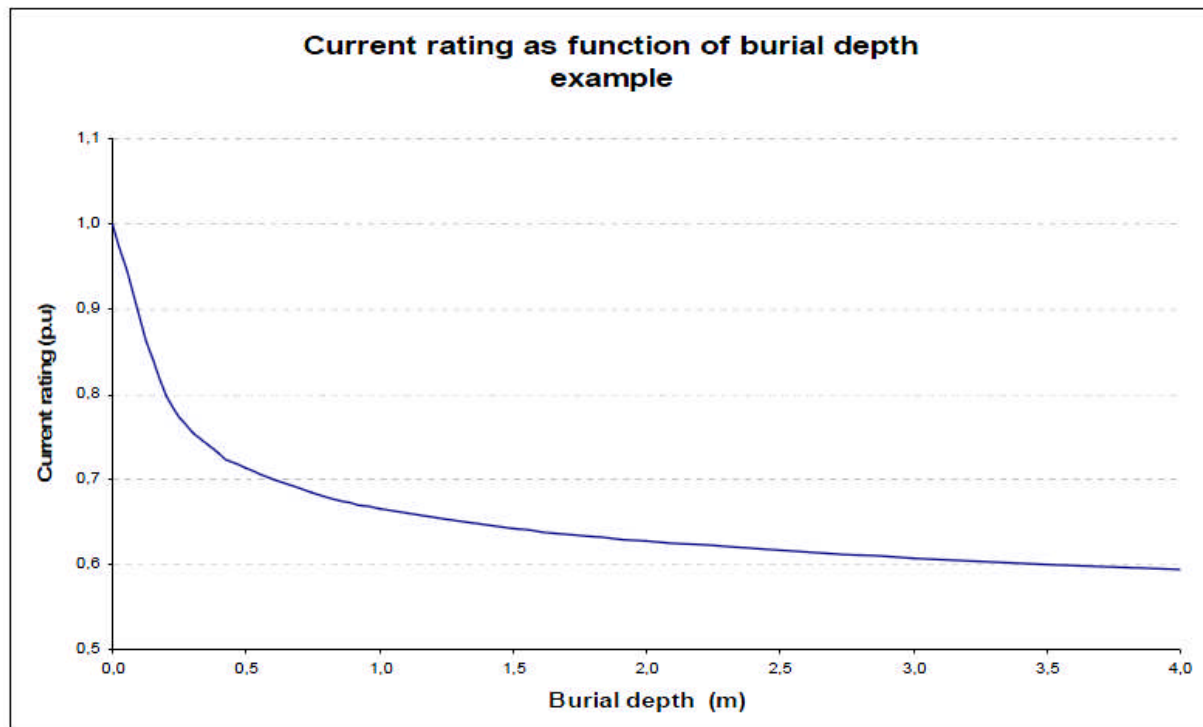
Another interesting graph is the electrical current rating decrease with depth, from temperature increases and ability to dissipate the heat.

Figure 4.16: Current Rating as a Function of Burial Depth (Example)
[Ref. 4.19]

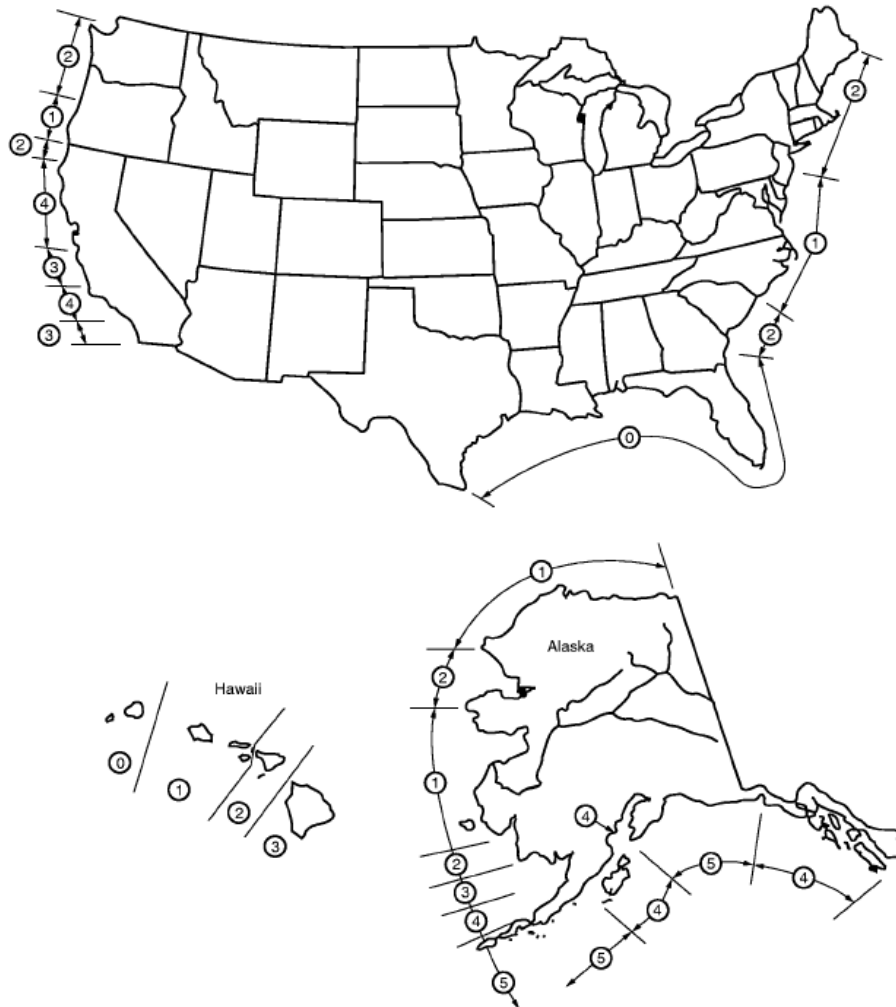
Seismic risk charts are given in API RP2A standard for fixed offshore platforms which although an older document shows a similar pattern of areas where risk is high and those where risk is low.

Figure 5.5: Seismic Risk in U.S. Coastal Waters (0 is low, 5 is high)

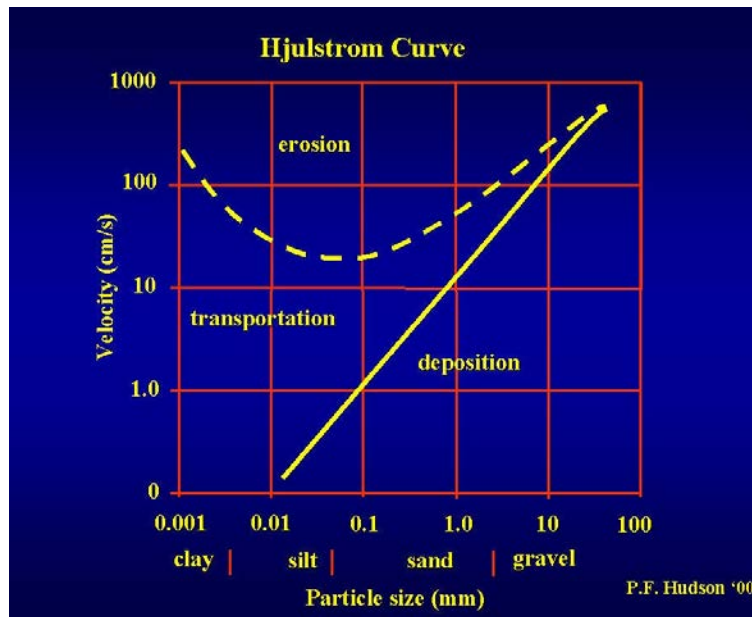
Figure 5.6: Diagram showing the relationship between stream velocity and ability to transport material of varying sizes.

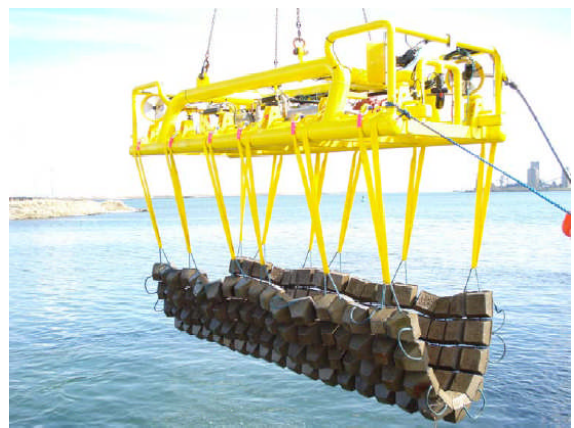
Figure 5.7: ROV deployment of concrete protection

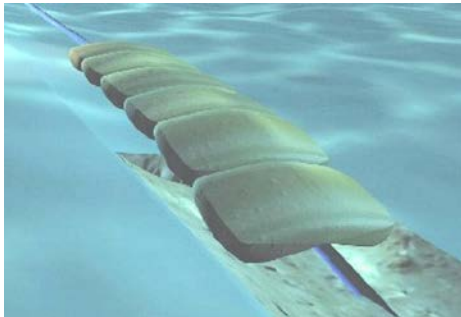
Figure 5.9: Concrete Bags Protection

Figures 5.9 and 5.10 give variations of the concrete bag and mattress protections.

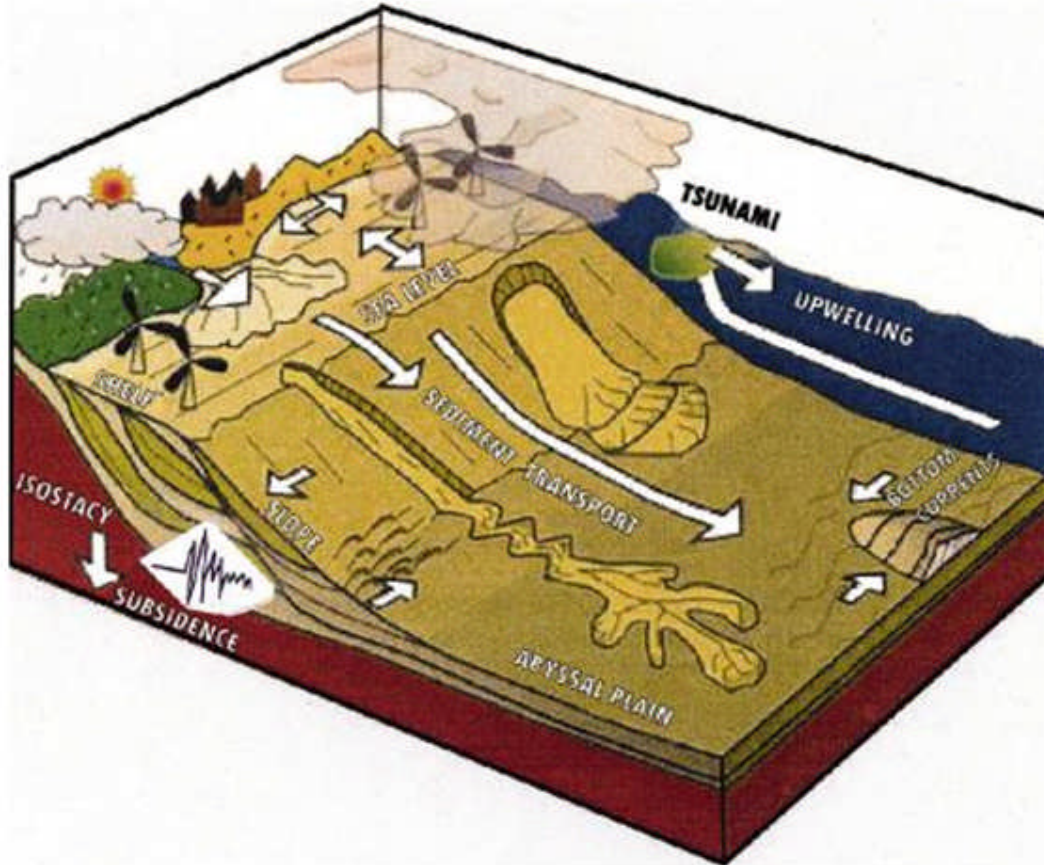
Figure 6.1: Cartoon examples of various geohazards.

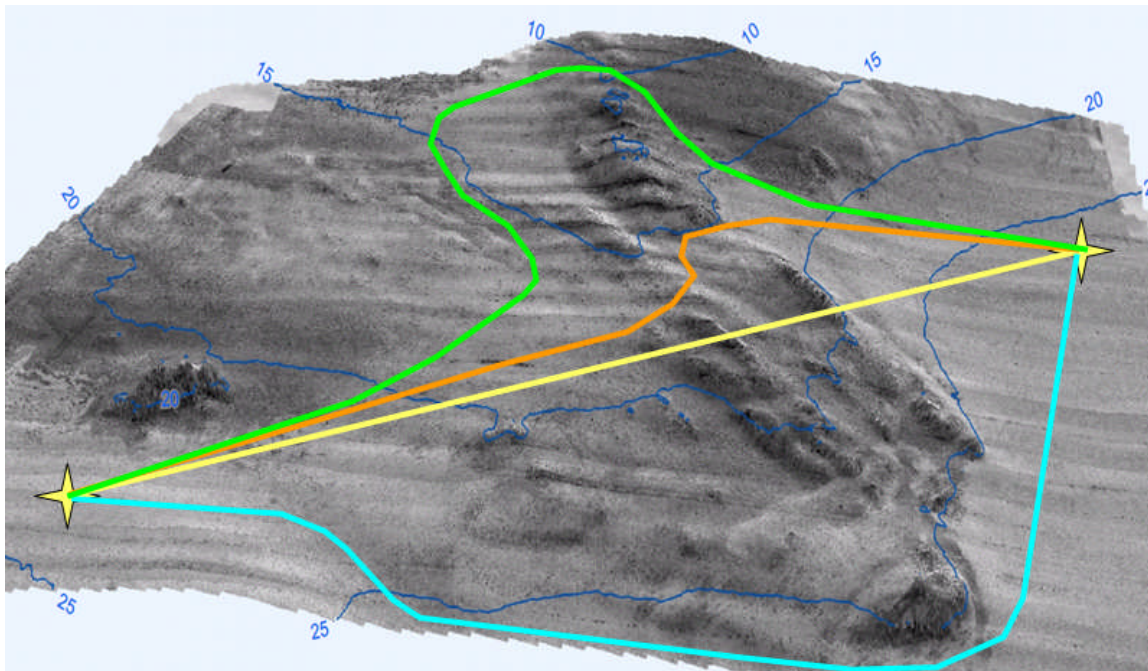
Initial Planned Route – The shortest cable route from A to B will not always be the most technically suitable or cost effective solution as illustrated in the Figure below.

Figure 6.2: Four Alternates Routes from one location to another as a function of topography.
[Ref. 5.10]

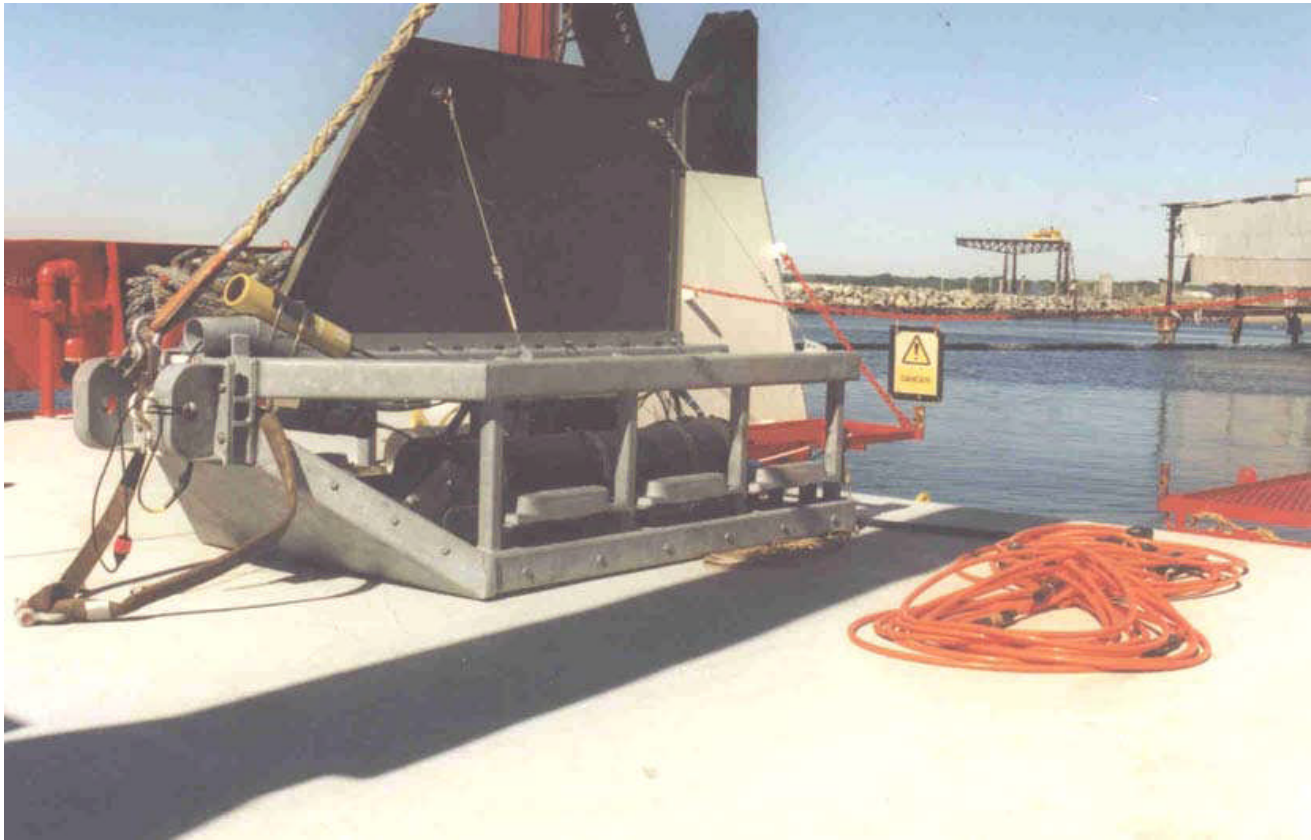
Figure 6.5: Typical Burial Assessment Survey Sled
[Ref. 6.9]

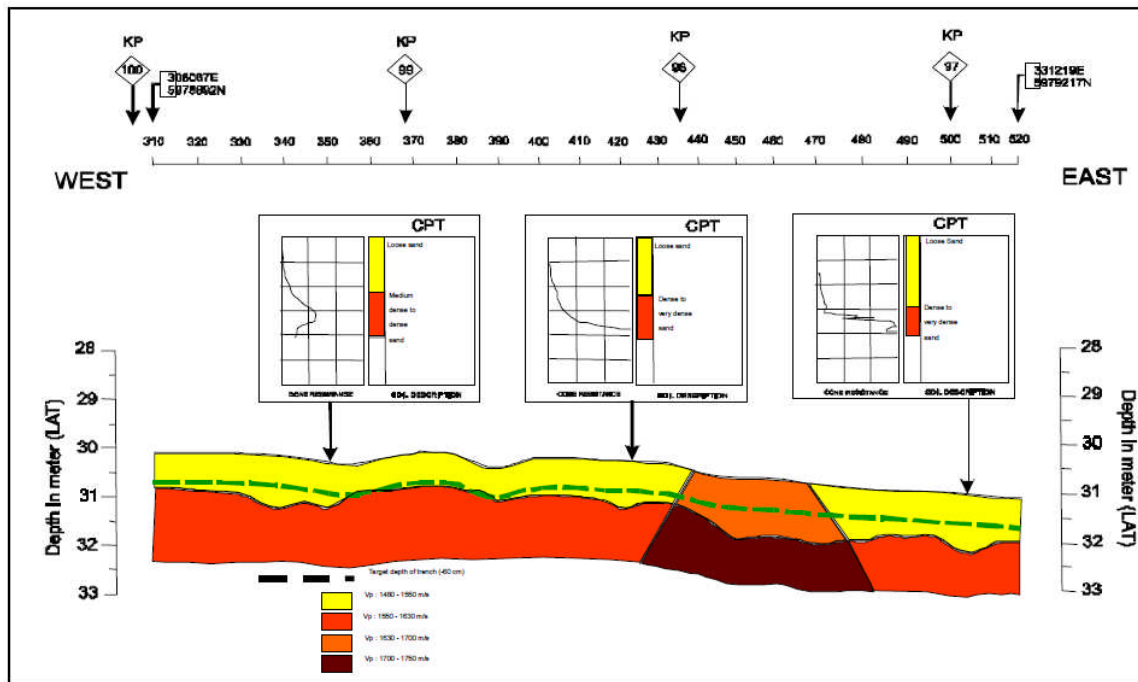
An example of the one of the final products of the Burial Assessment is shown illustrated in Fig. 6.8. Note that the yellow area at the sea bottom is loose sand and the red area below shows dense to very dense sand. The dotted green line shows the route the cable will take buried at about 3 feet in this example. The CPT surveys are located along the route in confirmation of the findings.

Figure 6.8: Burial Assessment Example Graphic Final Product
[Ref. 6.15].

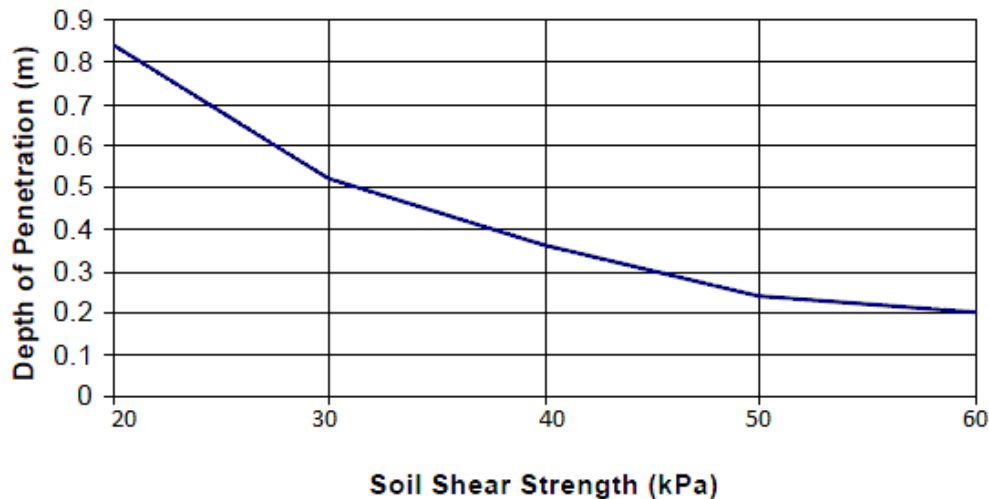
A further reference shows more detail indicating the conservative nature of Table 7.1 that in clay the fishing trawl gear has low penetration:

Figure 7.3: Relationship between Trawl Door Penetration and Soil Shear Strength
[Ref. 3.43]

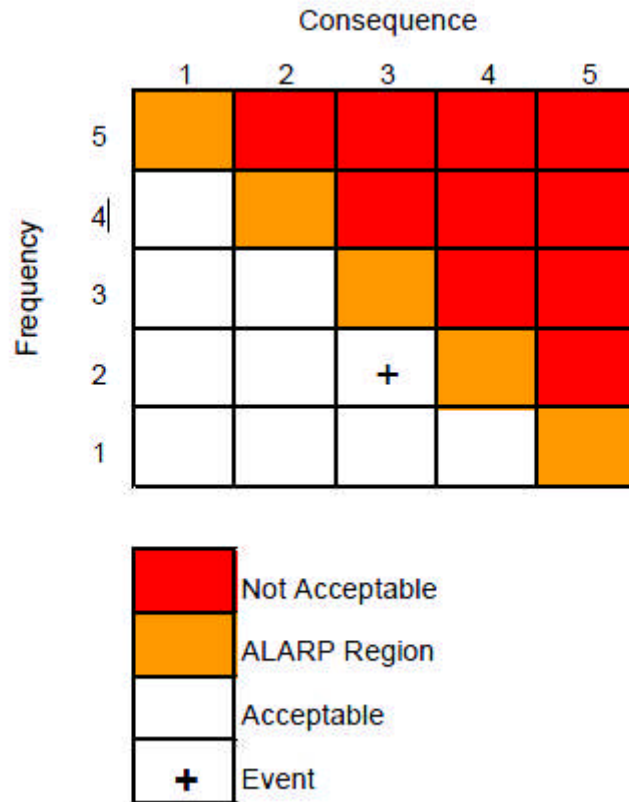
The same basic information needs to be available as in the quantitative risk analysis but instead of calculating probabilities through a fault tree analysis, estimates of whether the risk is high, medium or low is determined by a set of Rules drawn up for a HAZID. The evaluation of these results in developing mitigations if the total risk comes out to be unacceptably high and thus the unacceptable issues can be re-evaluated to confirm if they are acceptable when mitigating steps are taken. The method is considered equally valid but how well it is carried out depends more on the experience of the personnel assembled. The personnel assembled may include experts on fishing vessel equipment, local port officials, an insurance claims personnel, cable expert, and ship's master etc. in order to determine the risks and consequences based on the background information developed. The group, then in concert, places the probabilities and consequences on a risk matrix. The Risk Matrix can consist of various sizes, and a 5 X 5 matrix is illustrated in Fig. 7.5.

Figure 7.5: Frequency vs Consequence Matrix

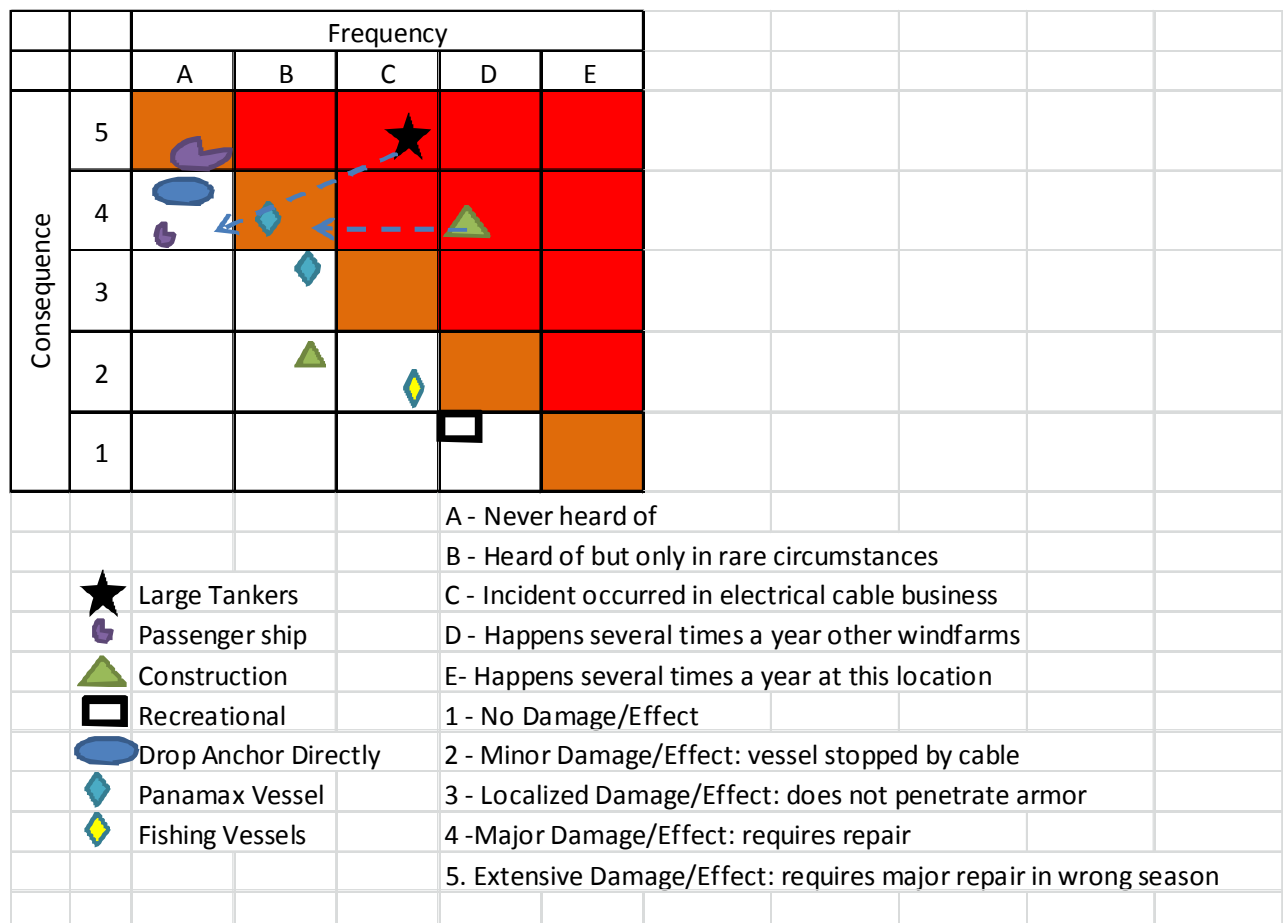
Figure 7.6: Risk Analysis Matrix

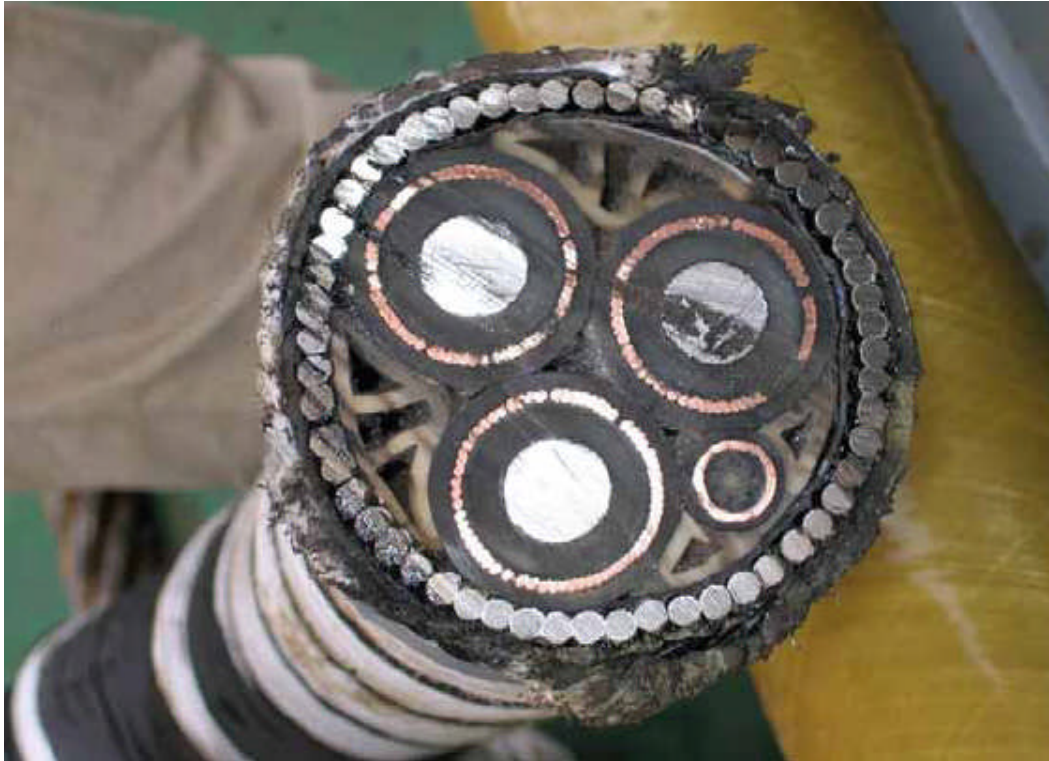
Figure 8.1: Cross Section of Cable with Single Armor Layer.

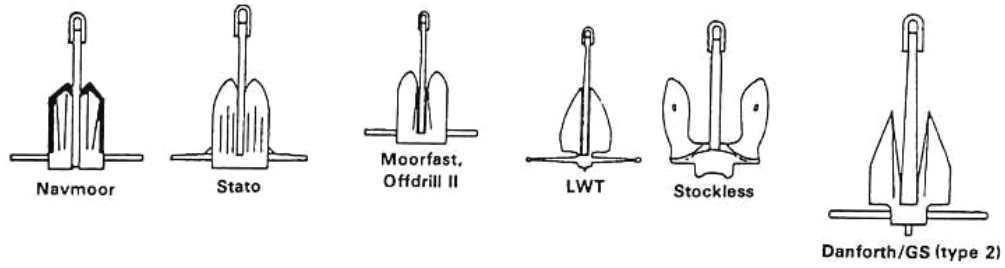
Figure 8.2: Typical Ship Drag Embedment Anchors

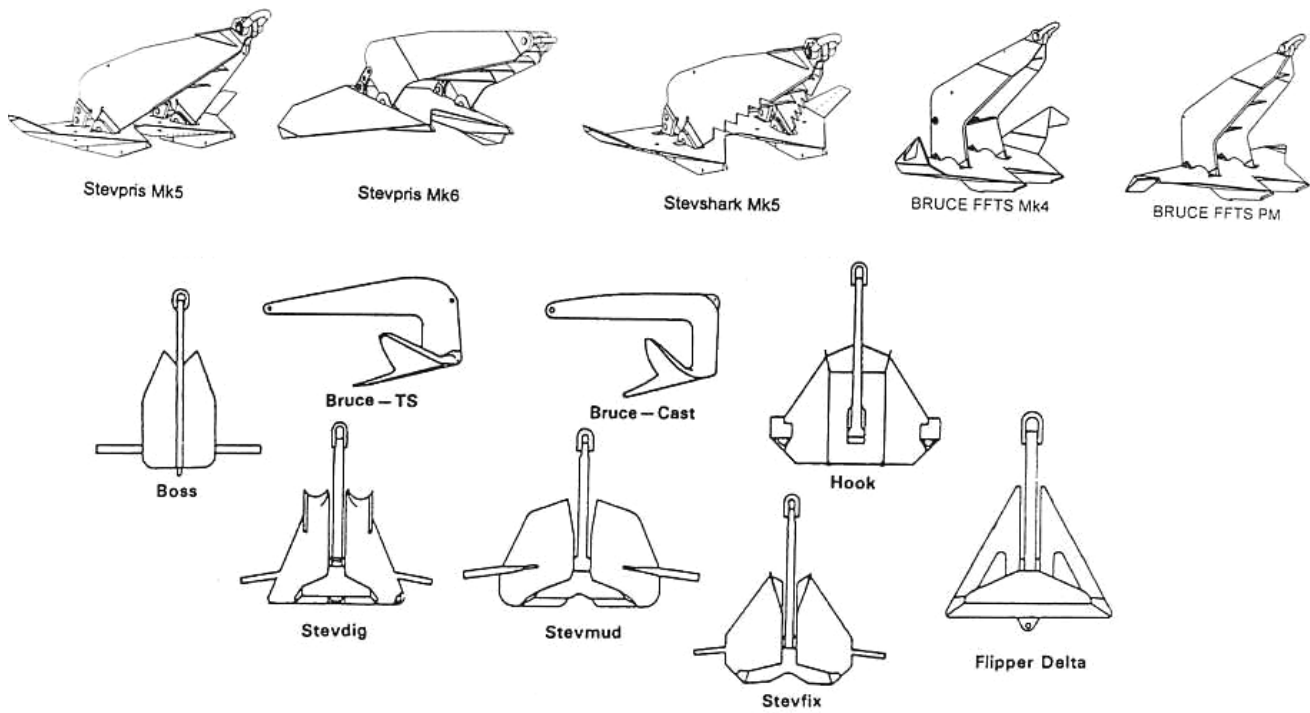
Figure 8.3: Typical Offshore Rig Anchors

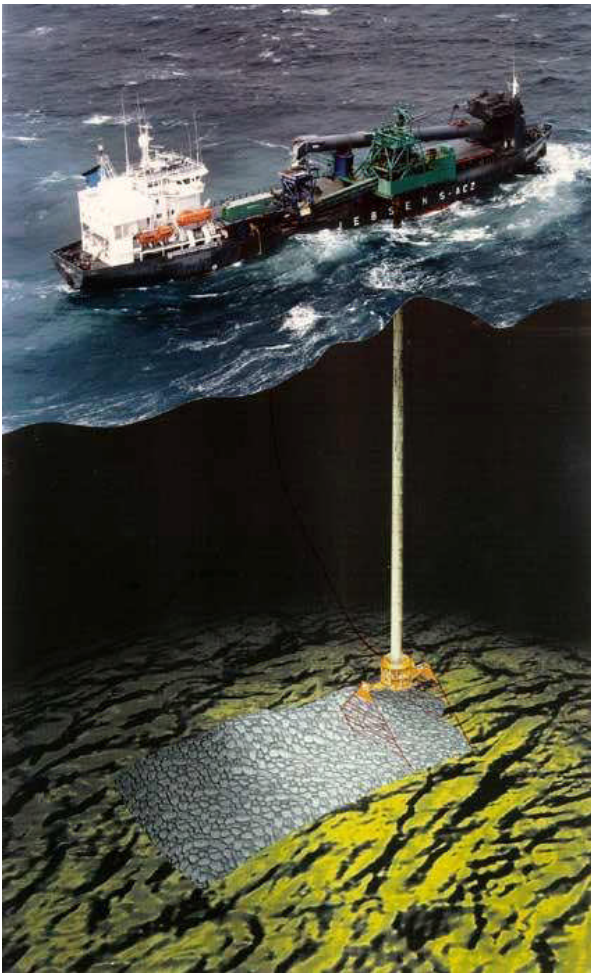
Figure 8.9: Cartoon of Rock dumping

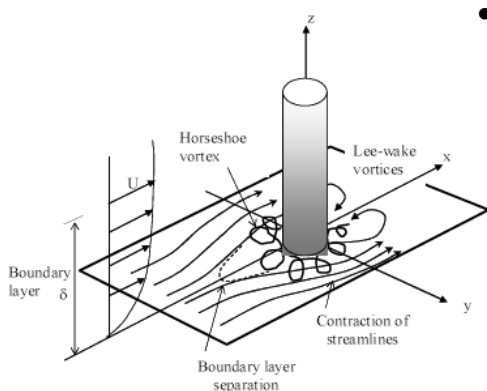
Figure 1
Flow around the base of a vertical pile

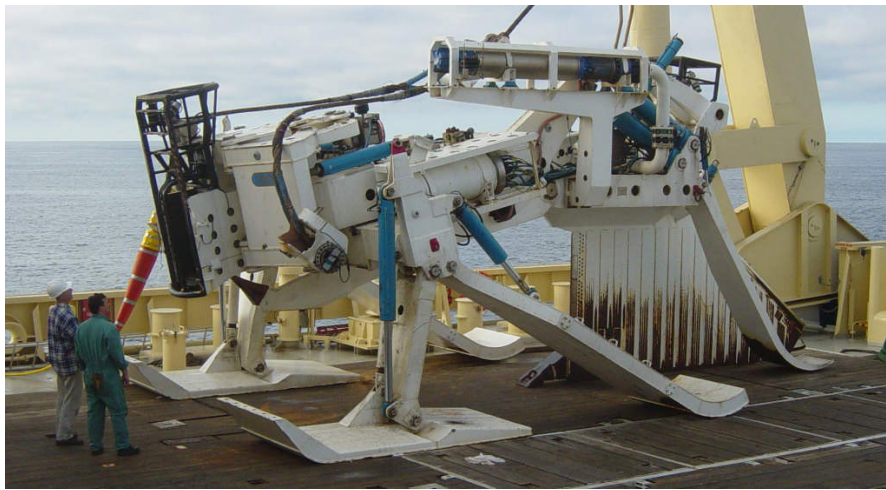
Figure 9.2: shows a plow as per Figure 9.3, providing a better view of the details of the “share”.

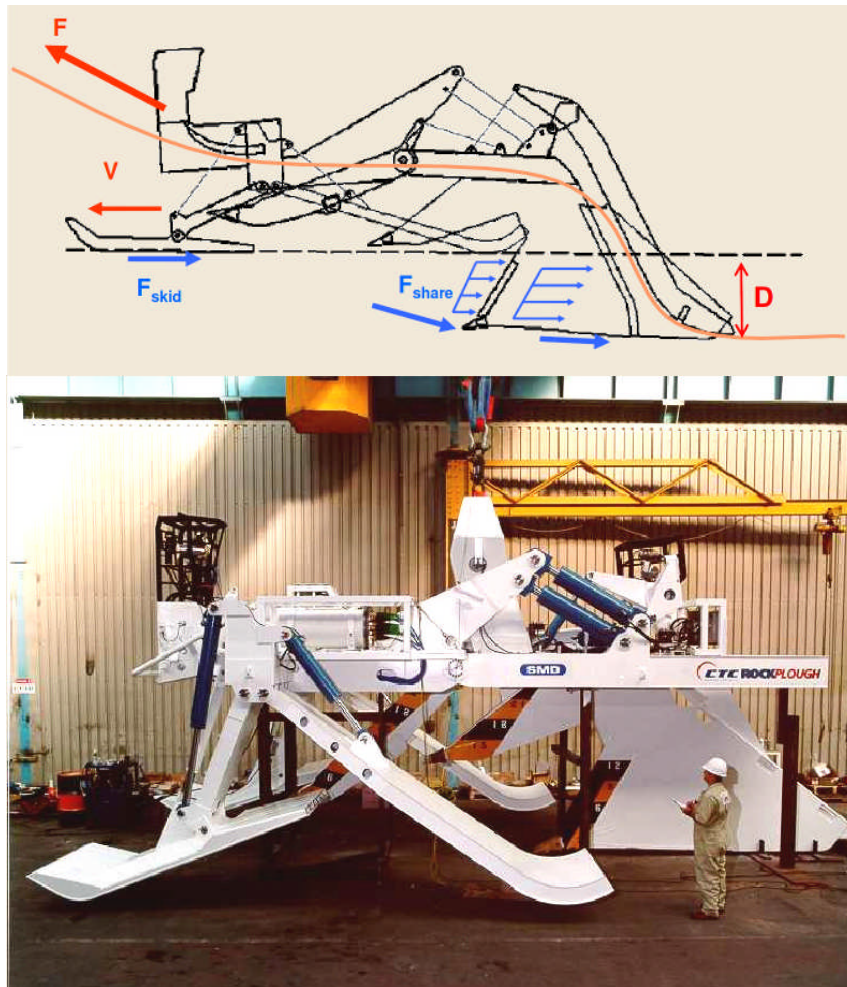
Figure 9.3: Plow showing forces in Cartoon (above) and plow below: note the “share” is the “plowshare” which is a V shape tip that cuts through the soil.

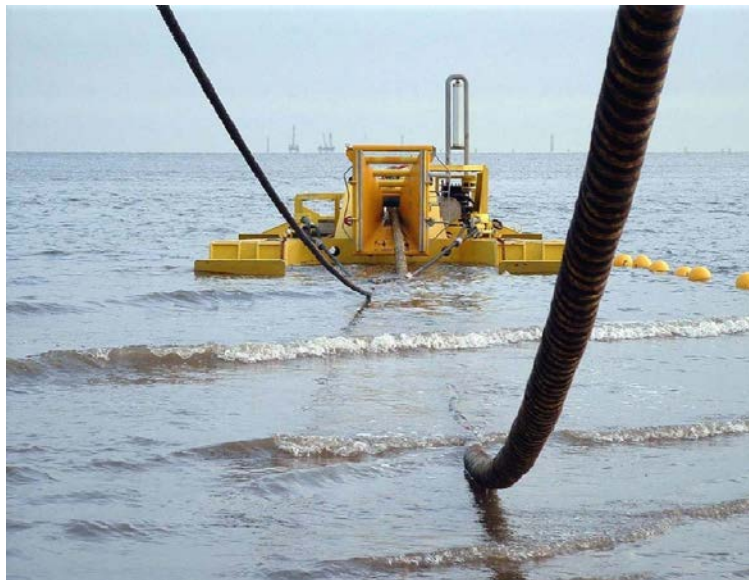
Figure 9.5: Sea Stallion 4 Cable Plow Burying North Hoyle Export Cables up the Beach
(Photo courtesy of The Engineering Business Ltd)

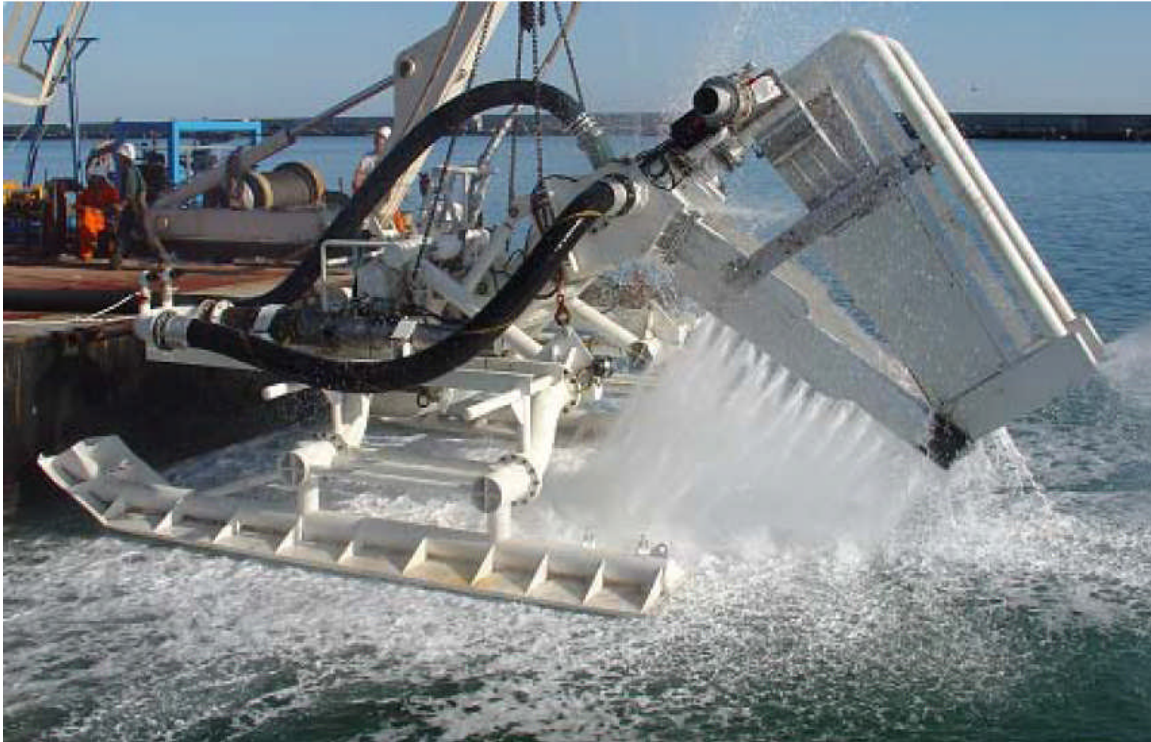
Figure 9.6: Cable Jetting device. The sword carrying water nozzles is visible and working.
(Courtesy of L D Travocean, France)

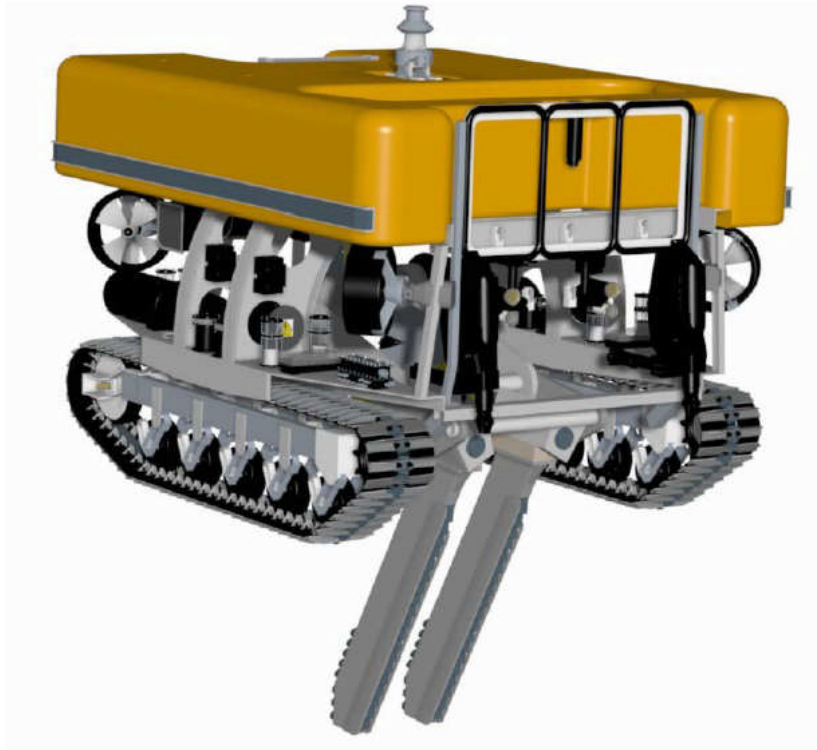
Figure 9.7: Jet Plow - Perry Slingsby.

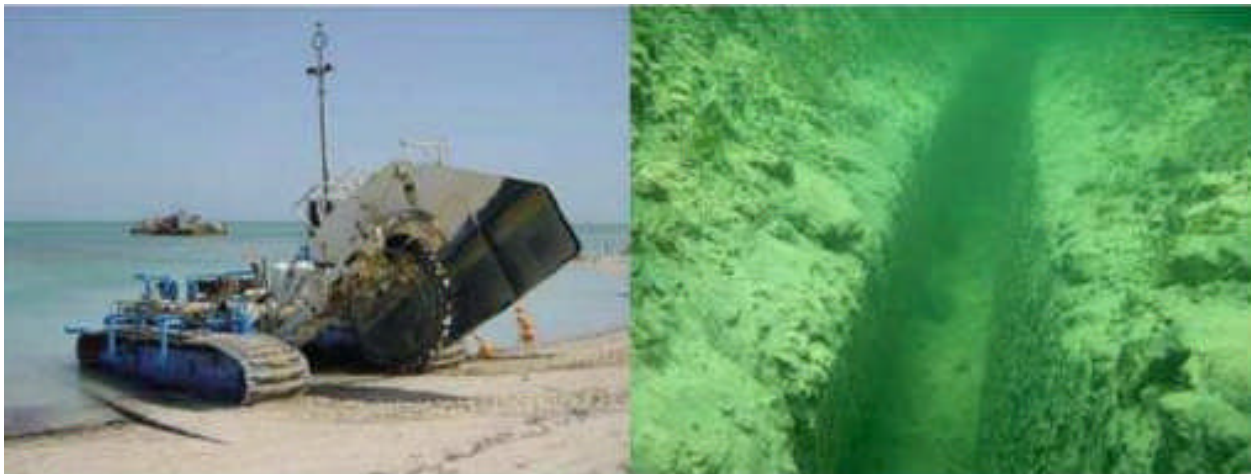
Figure 9.9: Wheel cutter for rocky sea floor
Cable trench cut into calcarite sea floor (Courtesy of L.D. Tranvocean) [Ref. 3.36]

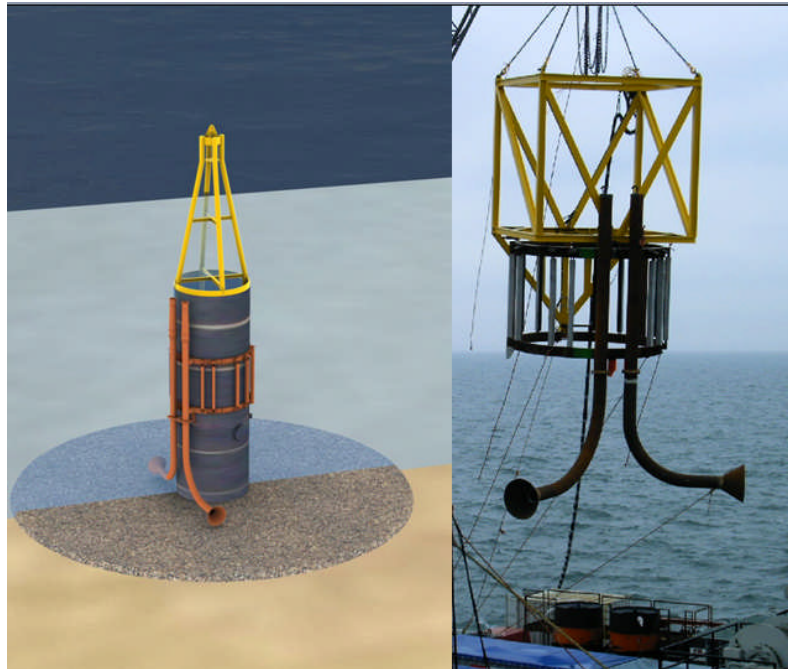
Figure 9.11: J –Tube assembly.

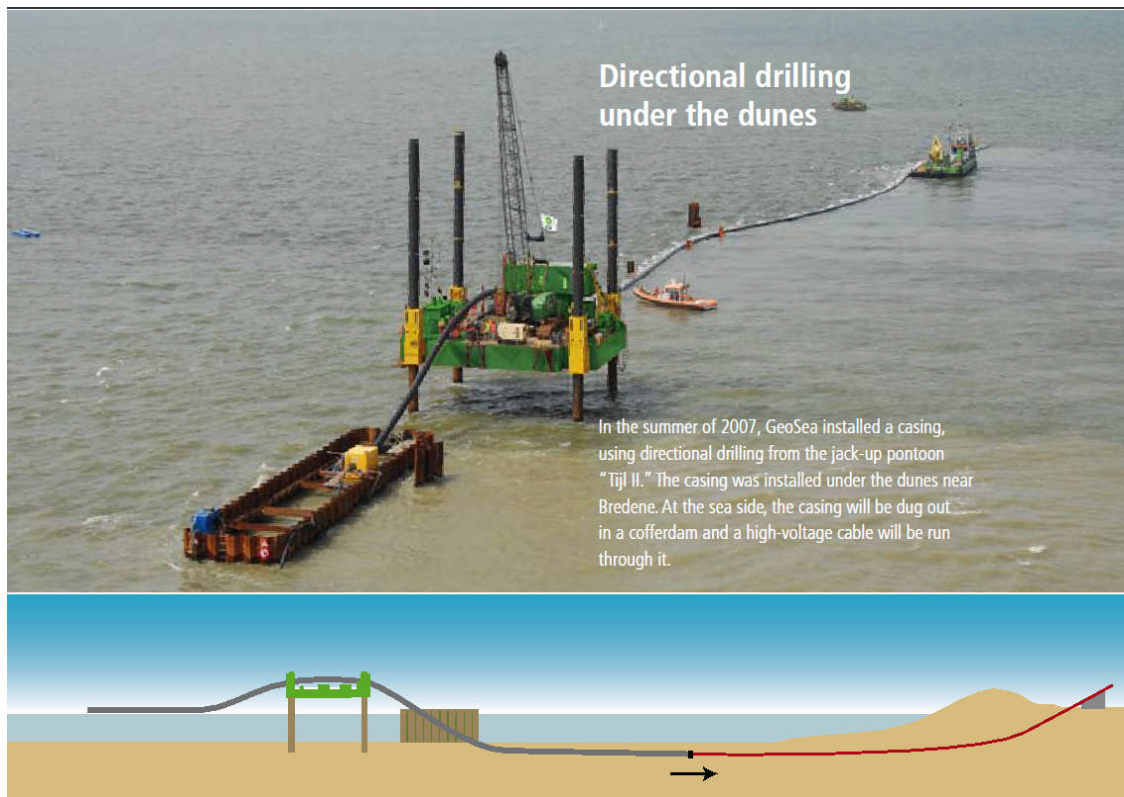
Figure 9.16: showing a connection made in a cofferdam at the beach (Netherlands)

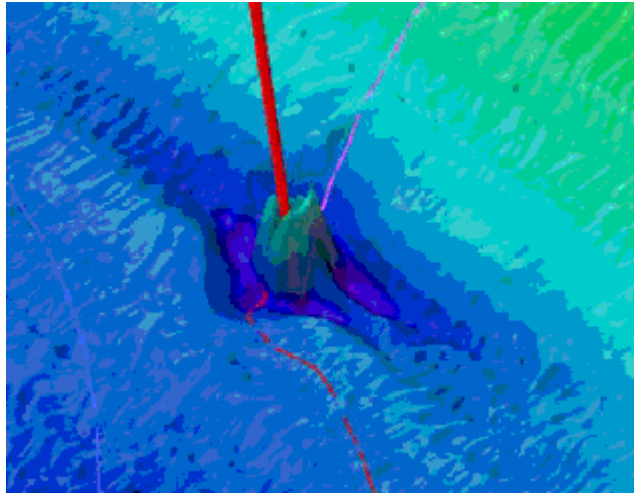
Figure A.1: Scroby Sands Illustration of Scour

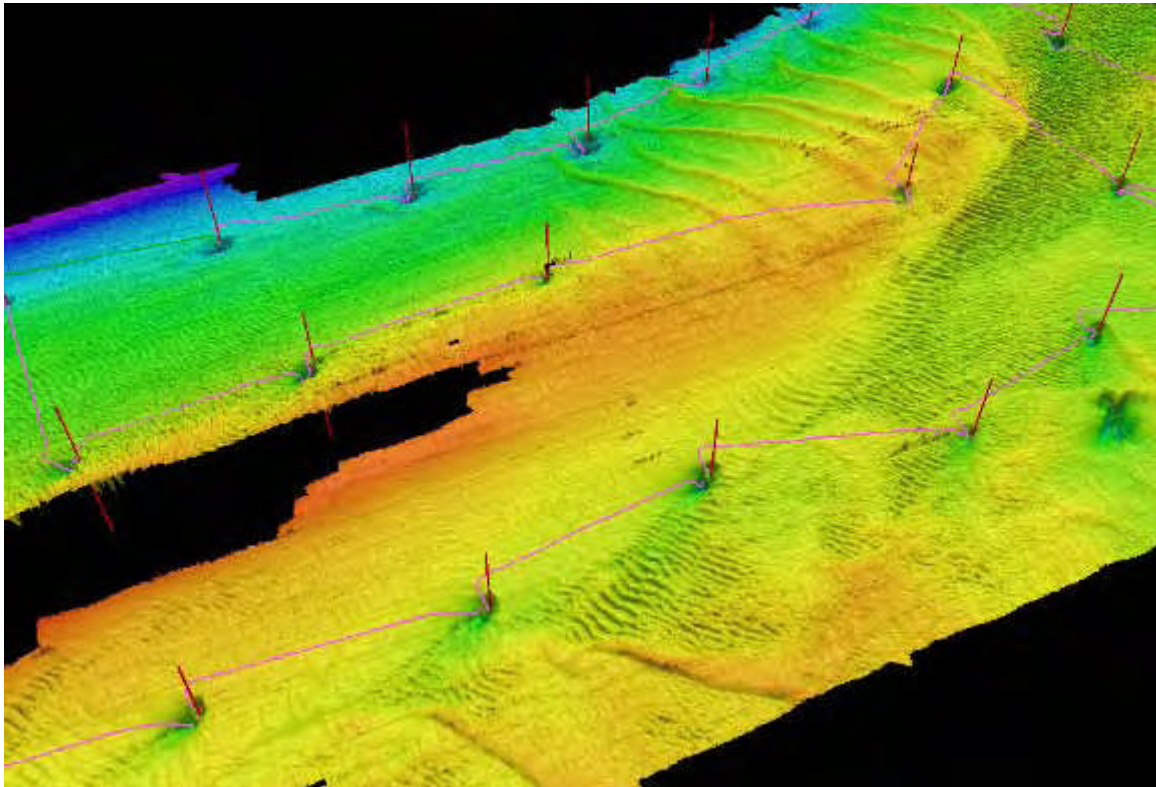
Figure A.2: Fledermaus image showing the survey of February 2005 from the Scroby Sands Offshore Wind Farm.

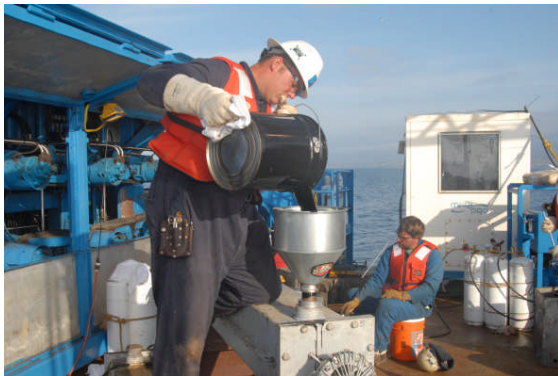
Figure A.7: Splice box being filled with No-Void
