1 **Request IR-1:**

3 **What is the P99 budget for the Maritime Link project, and what is the P99 scheduled**
4 **completion date?**

The challenge of ensuring the integrity of the submarine power cables: getting the power back to shore is the subject of this Report. Some 70% of insurance claims for offshore wind farms come from the submarine cables. Loss of power, for an extended period may lead to further damages to the turbine equipment/structure.

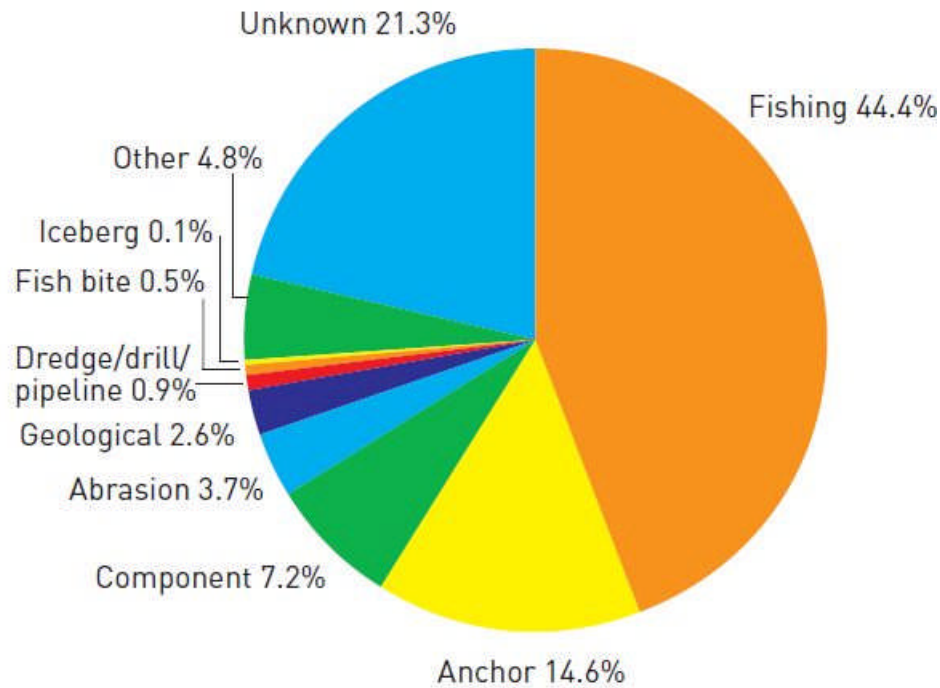
Figure A.10: Damage from 2,162 records spanning 1959–2006. Source: Tyco [Ref. 3.37]

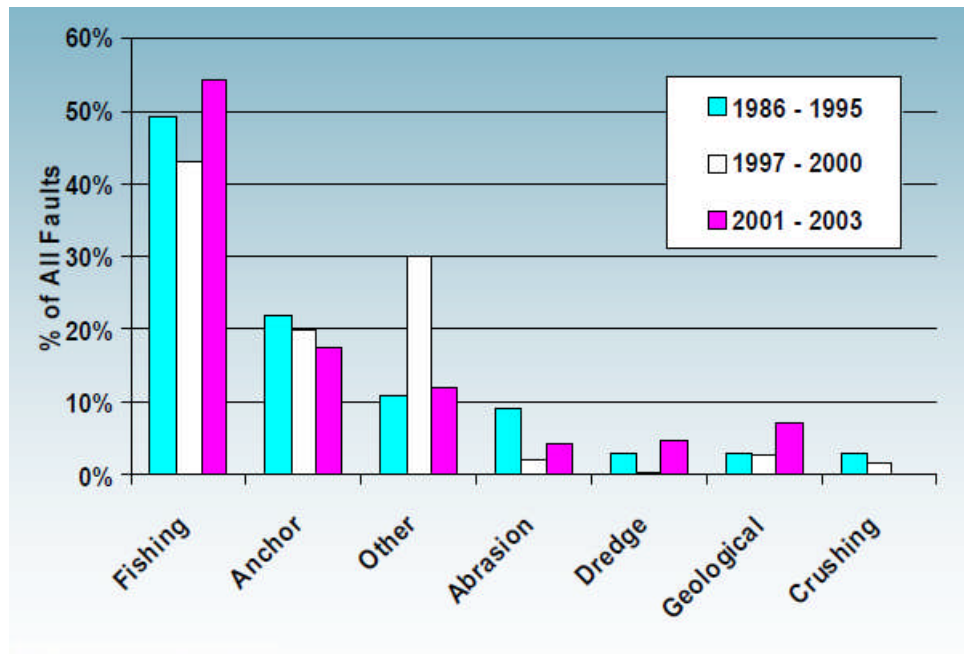
Figure A.13: Sources of External aggression from a Recent Paper on Cable Faults

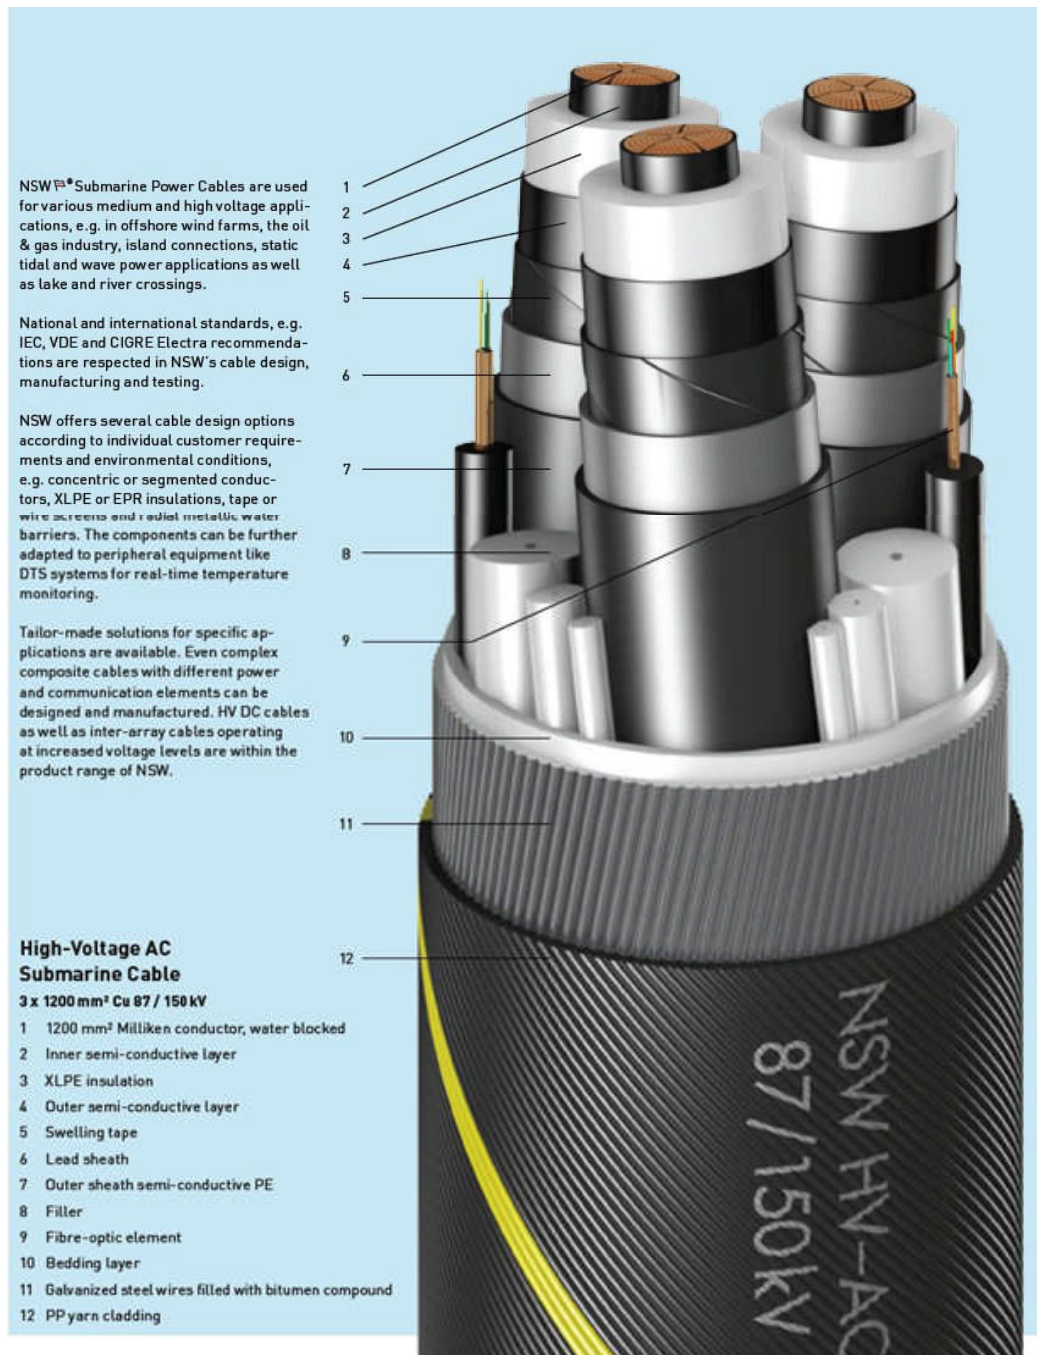
Figure B.1: Typical HVAC Submarine Power Cable: 3 Phase Bundled with Fiber-Optic Elements (Courtesy NSW)

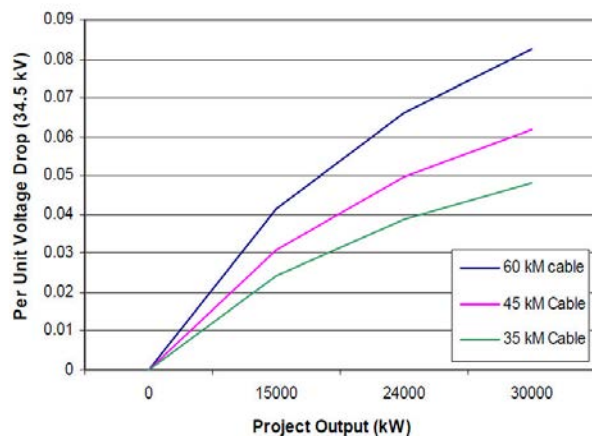
Figure B.2: Voltage drop characteristics

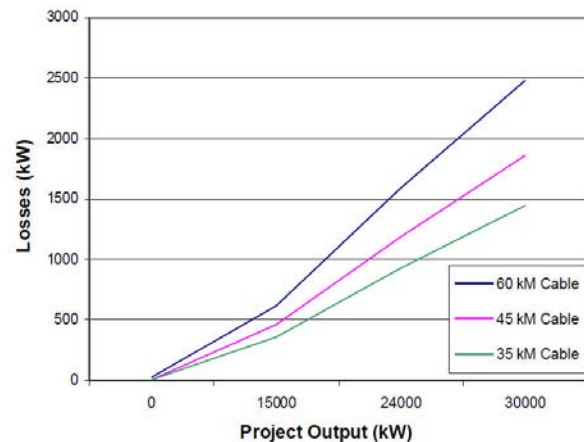
Figure B.3: Kilowatt (kW) loss characteristics

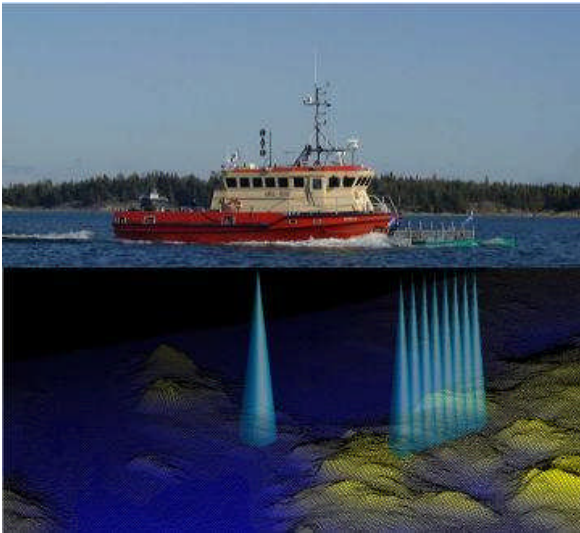
Figure C.1: Single Beam and multiple single beam echo sounder.
[Ref. C.2]

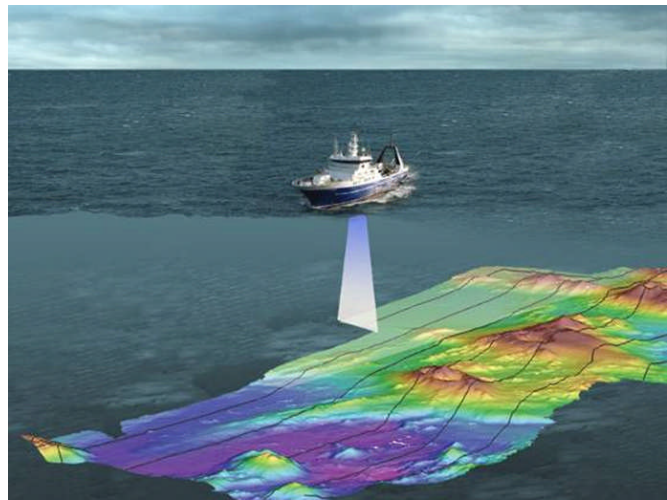
The multi-beam echo sounder is an ideal way to develop a topographic map as shown in Figure C.2. The flattest path for a cable is preferred as it is the least difficult to lay, with no unsupported lengths. It is important to use this surveying technology so that the safest cable route can be planned in order to eliminate potential damage from the cable as well as extend the cable's life span.

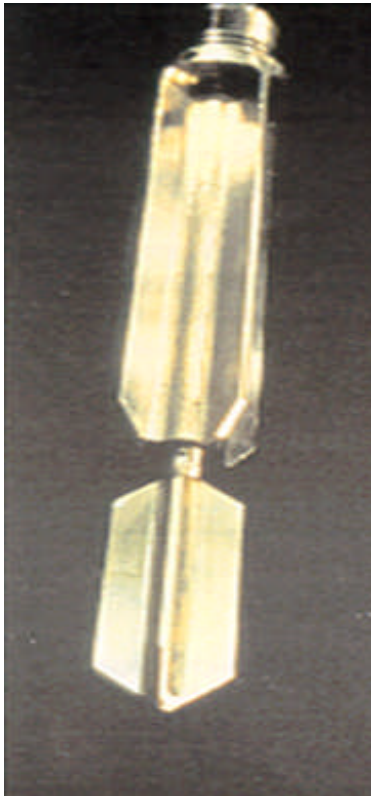
The vane shear test measures undrained shear strength of clay. The test consists of forcing a vane equipped with four orthogonal blades into the soil and then rotating the shaft and blades until soil failure. Maximum torque value must be measured and recorded. Afterwards the remoulding shear resistance of the soil can be measured rotating the vane for several turns.

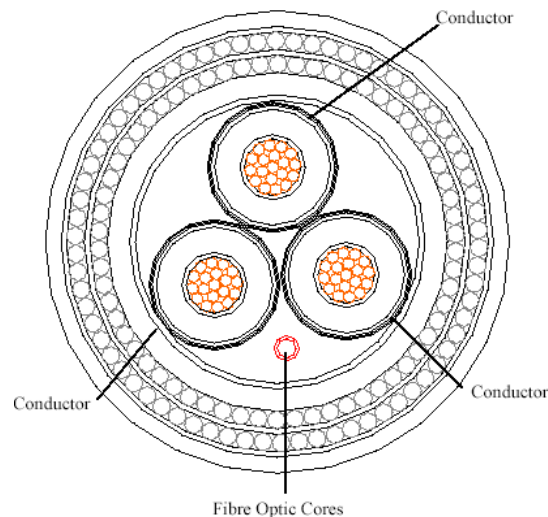
Figure E.3: Cross Section of 70 Sq. mm Double Armor with 16 fibers Optic Package
